Manhole Inspection Summary

Manhole # S39S__001MH

Insp Date: **3/12/08 12:54 PM**

Location Address: **602 hyson st**

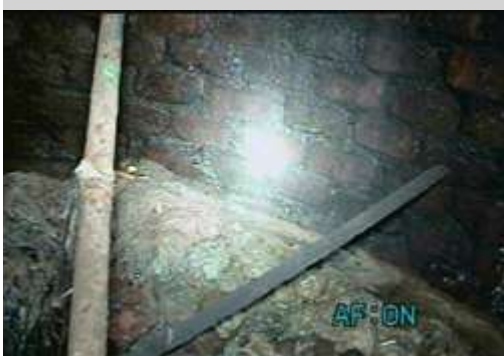
Defect 5

Condition: ☐ Sound ☐ Cracked ☐ Root Intrusion ☐ Deteriorated ☐ Leaks ☒ **Debris**

channel debris

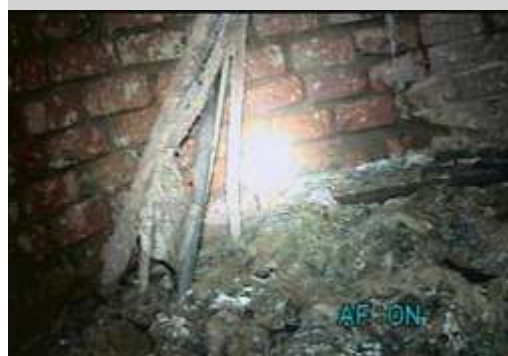
Defect 4

Condition: ☐ Sound ☐ Cracked ☐ Root Intrusion ☐ Deteriorated ☐ Leaks ☒ **Debris**

bench debris

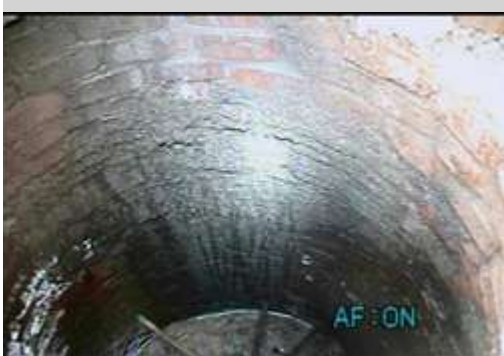
Defect 3

Infiltration: ☐ None ☐ Joint ☐ Cracks ☐ Mortar ☐ Roots ☒ **Wall**

barrel & chimney infiltration

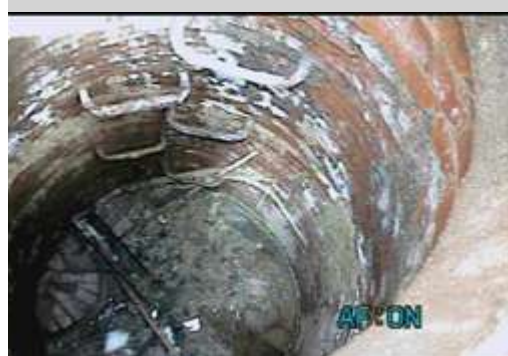
Defect 2

Count: **6** Missing: **0** ☒ **Corroded**

corroded steps

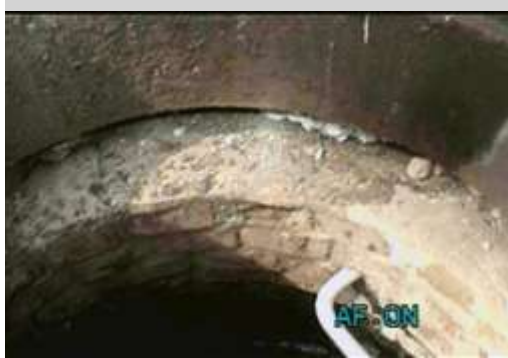
Defect 1

Offset: **4** (in.)

Condition: ☐ Sound ☐ Cracked ☐ Root Intrusion ☒ **Loose Brick** ☐ Deteriorated

chimney loose bricks frame offset

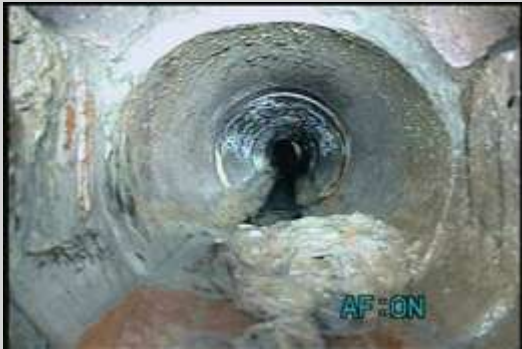
12 O'Clock Outflow

Deposits: ☐ None ☐ Mud ☐ Gravy ☒ **Debris** ☐ Grease

Silt Depth: **2** (in.) Deposits Extent: **Light**

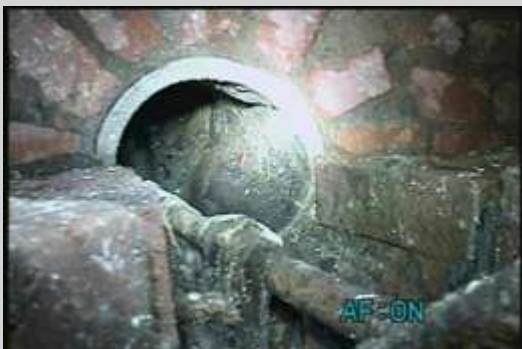
2 O'Clock Inflow

Deposits: ☐ None ☒ **Mud** ☐ Gravy ☒ **Debris** ☐ Grease

Silt Depth: **2** (in.) Deposits Extent: **Medium**

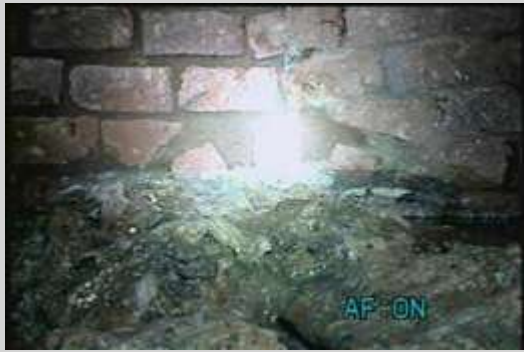
6 O'Clock Inflow

Deposits: ☐ None ☐ Mud ☒ **Sludge** ☒ **Debris** ☐ Grease

Silt Depth: **8** (in.) Deposits Extent: **Heavy**

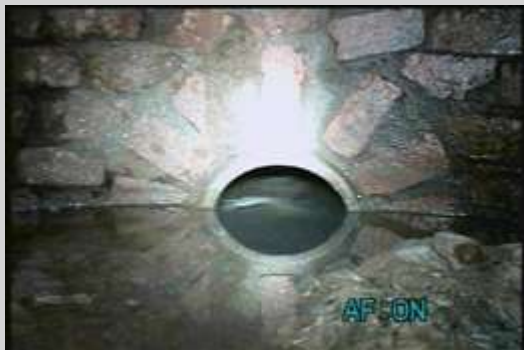
8 O'Clock Inflow

Deposits: ☐ None ☐ Mud ☐ Sludge ☒ **Debris** ☐ Grease

Silt Depth: **5** (in.) Deposits Extent: **Heavy**
